**DIVISION OF CONSTRUCTION
TRANSPORTATION LABORATORY
RESEARCH REPORT**

**EVALUATION OF STEEP CUT
SLOPES IN POORLY
CONSOLIDATED SEDIMENTS**

CA-11-2132-77-31

NOV. 1977

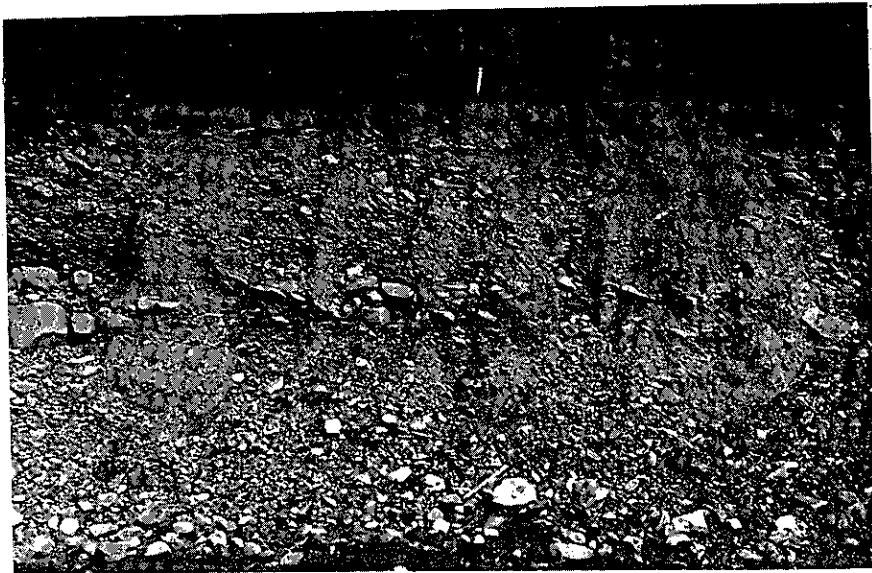
Photo 1

Pebbles and cobbles in the gravel and conglomerate layers range from a few inches to a foot or two in diameter (see Photo 1). Where slightly cemented they stand well on steep slopes. However, where cementation is lacking, they have a tendency to ravel extensively.

Gravel Unit of San Benito Gravels
2/16/73

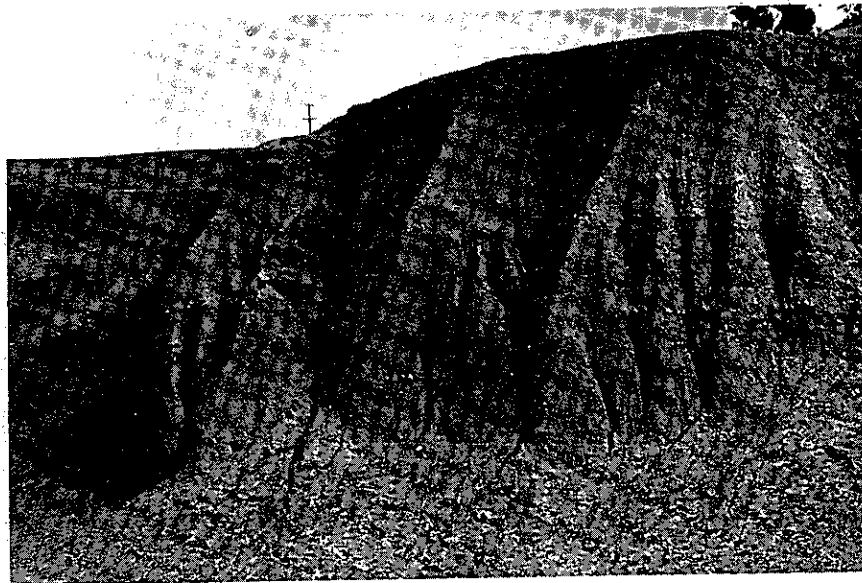
Photo 2

Poorly cemented sandstones of the San Benito Gravels are usually more stable than the finer sediments and stand well on steeper slopes. When they erode they often produce a fluted effect (see Photo 2).

Slightly Cemented Sandstone
Unit of San Benito Gravels
7/15/72
